Optimizing consumable life in mechanized plasma cutting

Identifying and correcting typical problems

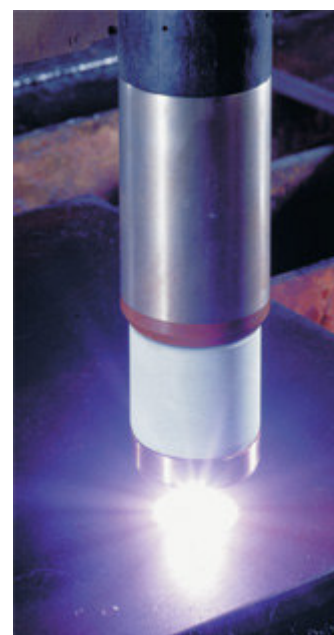
Figure 1

Technology improvements have helped to extend the life of consumables for mechanized plasma cutting systems. One such advancement is the development of improved front-end torch shielding.

These machines have helped increase consumable life in oxygen cutting applications. In addition, consumable design developments such as front-end shielding (see **Figure 1**) help improve piercing capabilities, and electrodes featuring a silver/hafnium interface (see **Figure 2**) for improved cooling have helped increase electrode life and reduce cutting costs.

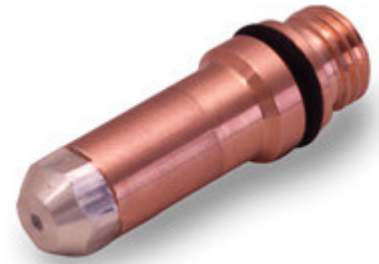
Figure 2

Material advancements, such as the silver/hafnium interface on this electrode, have also contributed to longer consumable life.

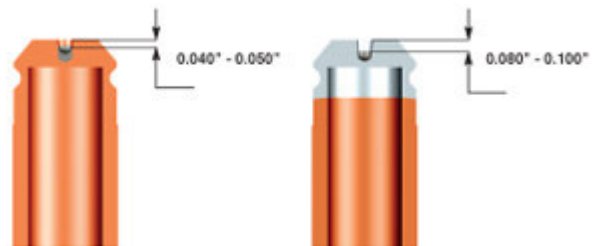
Figure 3

Watching the pit depths of both all-copper (left) and silver/hafnium electrodes is a good guide to determine changeout.

As a rule of thumb, change out standard all-copper electrodes when the hafnium pit depth reaches 0.040 to 0.050 inch (see **Figure 3**). On silver/hafnium interface electrodes, this pit depth may be doubled to 0.080 to 0.100 in. before changeout should be needed.

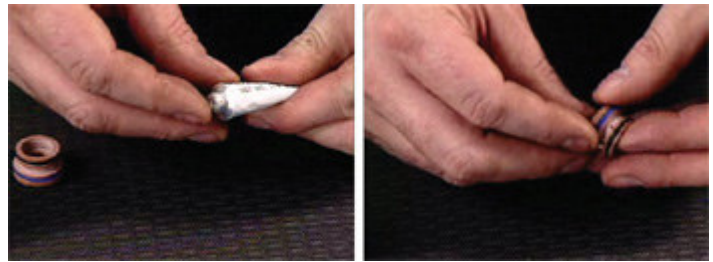
Figure 4

If you want to extend the lives of O-rings, you need to apply proper lubrication. A small dab on the fingers and a gentle rubdown on the O-ring's surface will do the trick.

Proper technique involves putting a very small amount of lubrication on your fingers, rubbing your fingers together, and then rubbing your finger on the surface of the O-ring (see **Figure 4**).

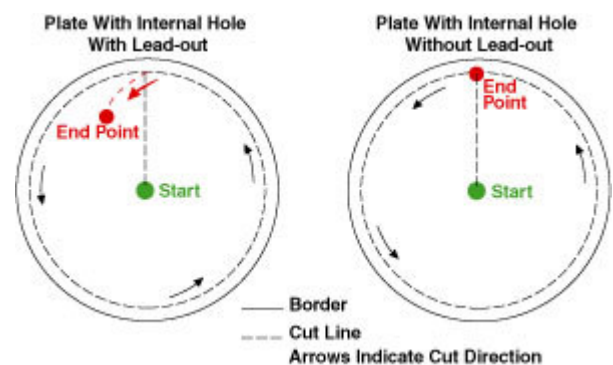
Figure 5

To extend the consumable life of a plasma system equipped with oxygen cutting capability, proper ramping down of gas pressures and power levels needs to occur at the end of the cut. This can happen only when the cut ends on the plate, as the illustration on the right demonstrates.

For proper ramp-down at the end of the cut, the cut must end on the plate. If the arc terminates abruptly because it runs off the plate, an excessive amount of hafnium can be ejected. This type of ramp-down error usually translates into a loss of between 10 and 15 arc starts.

If an application calls for cutting holes in plate, you can reduce ramp-down errors by programming the CNC to eliminate the lead-out at the end of the cut (see **Figure 5**).

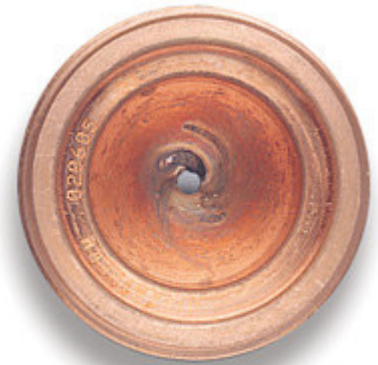
Figure 6

Low plasma gas flow at the beginning of a cutting job can lead to notched nozzle orifices.

That scenario leads to premature nozzle changeout.

Gas restrictions causing low flow rates can lead to catastrophic, almost immediate nozzle destruction. Because the initial plasma gas flow is low, the pilot arc attaches to the inside of the nozzle orifice and stays there long enough to cut the nozzle before being forced out of the orifice and transferring to the workpiece. This condition notches the nozzle orifice, virtually destroying it within only a few pierces (see **Figure 6**), and cut quality deteriorates immediately.

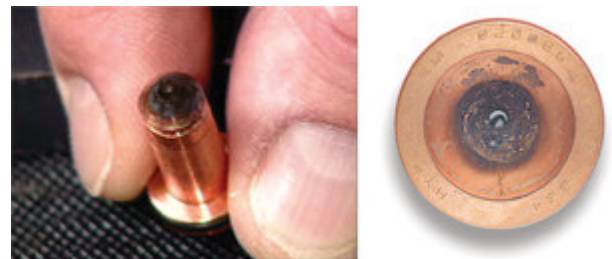
Figure 7

A blackened surface is considered a culinary delight in seafood circles, but in the world of plasma cutting, a blackened surface on an electrode end and inside a nozzle is a sign of gas contamination.

Gas contamination is indicated by a blackened surface on the end of the electrode and inside bore of the nozzle (see **Figure 7**).

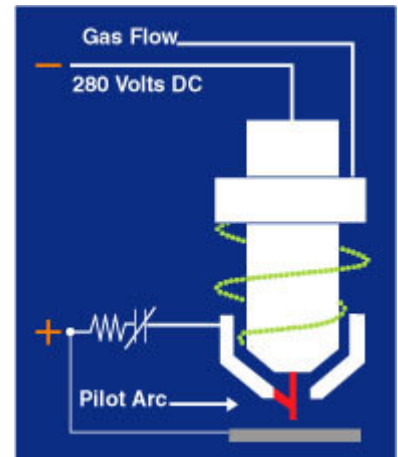
Figure 8

A poor electrical connection between the workpiece and the plasma power supply results in excessive pilot arcing and increased nozzle wear.

During the pilot arc phase of arc initiation, the arc is established between the electrode and the nozzle (see **Figure 8**). This puts tremendous heat load into the nozzle and causes rapid wear unless the arc transfers rapidly to the workpiece.

In a properly functioning mechanized system, arc transfer occurs within 100 milliseconds. Poor electrical connection from the workpiece to the power supply can delay that to 12 second or more, risking not only increased consumable wear, but also misfiring.
